DREAM-II Learning Event-IV

‘The Need for Integrated Spatial Development Planning: the Case of Gully Control near Jigjiga’

Gully Hazard Rapid Assessment Report

Overview of Gully Control Measures

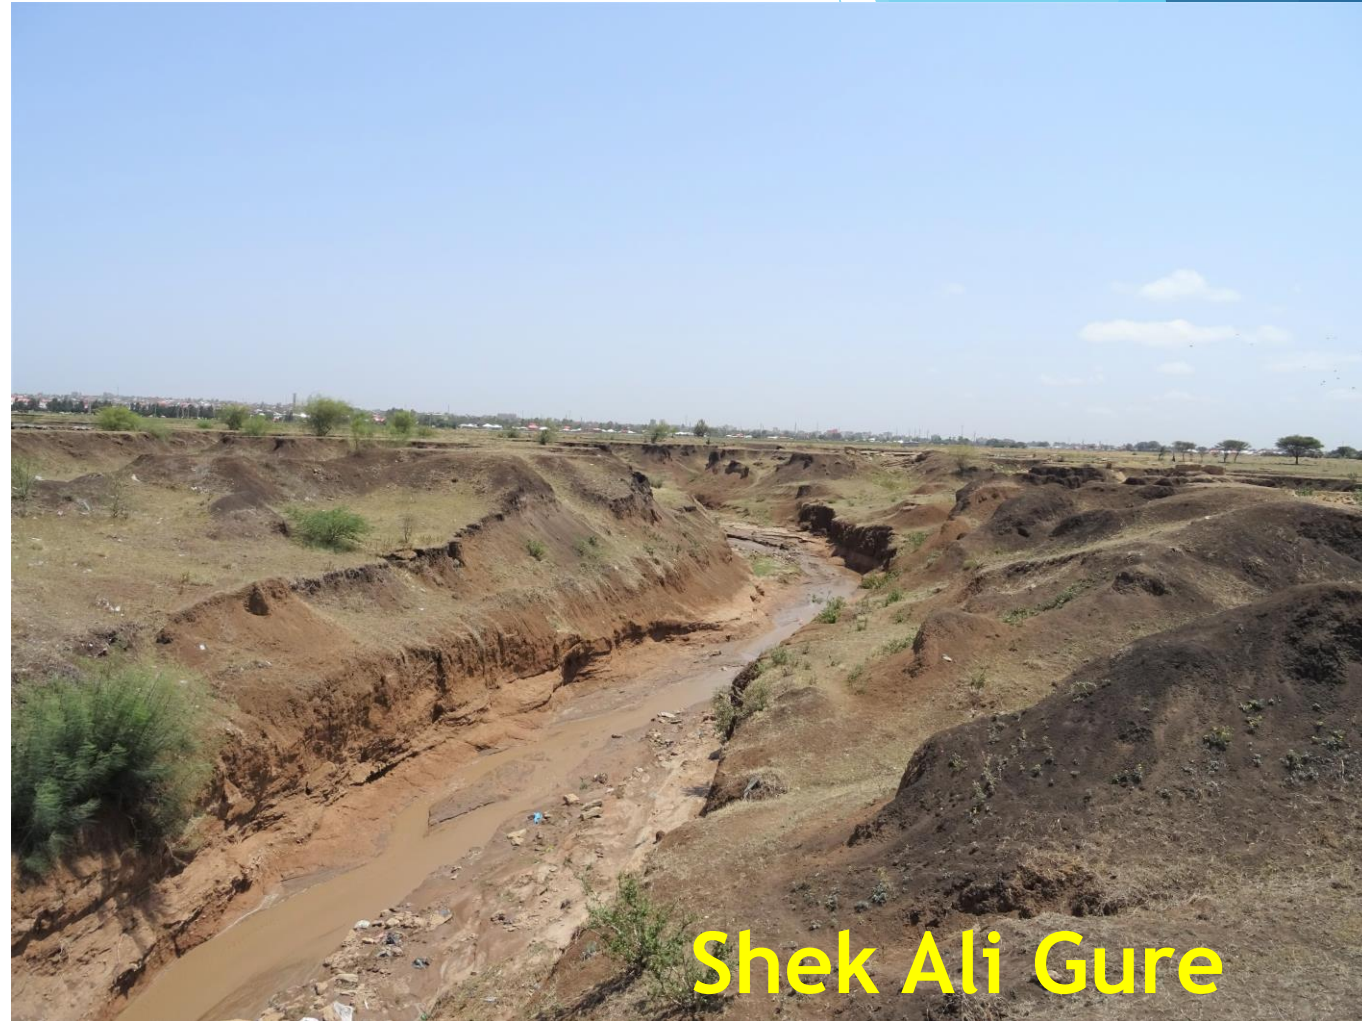
- ❖ A gully is a channel resulting from erosion and caused by **concentrated** but **intermittent** flow of water usually during and immediately following heavy rains
- ❖ Gully is visible manifestation of **misuse of land**

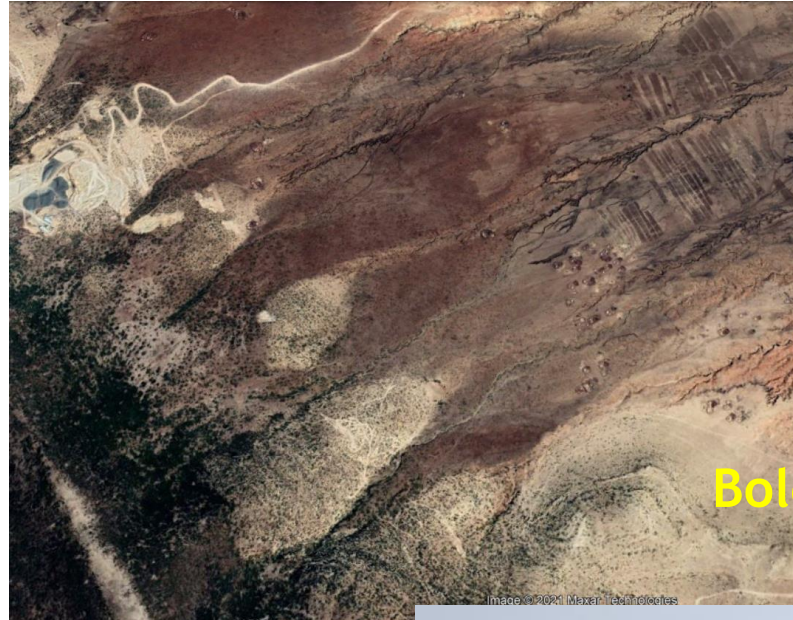
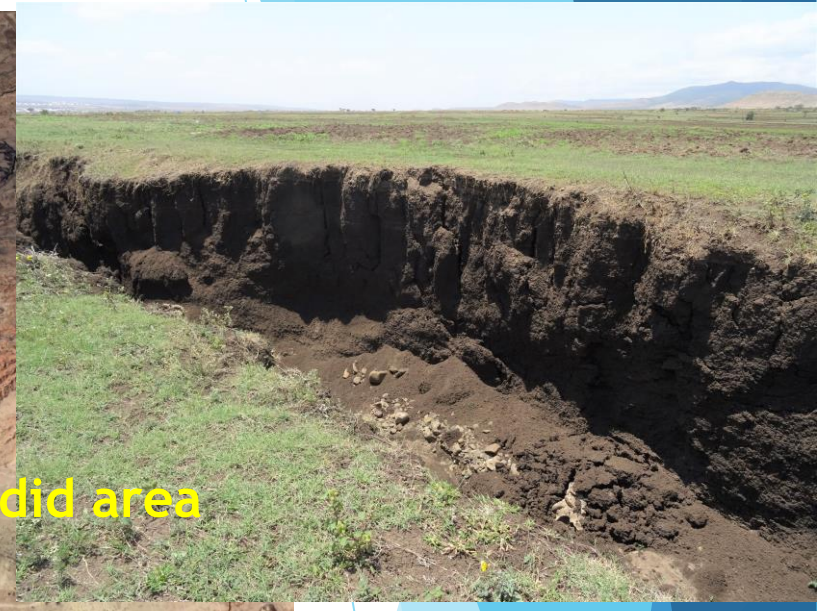
Boldid area

- Improper land use
- Deforestation
- Overgrazing
- Poor road construction
- Livestock/human foot paths

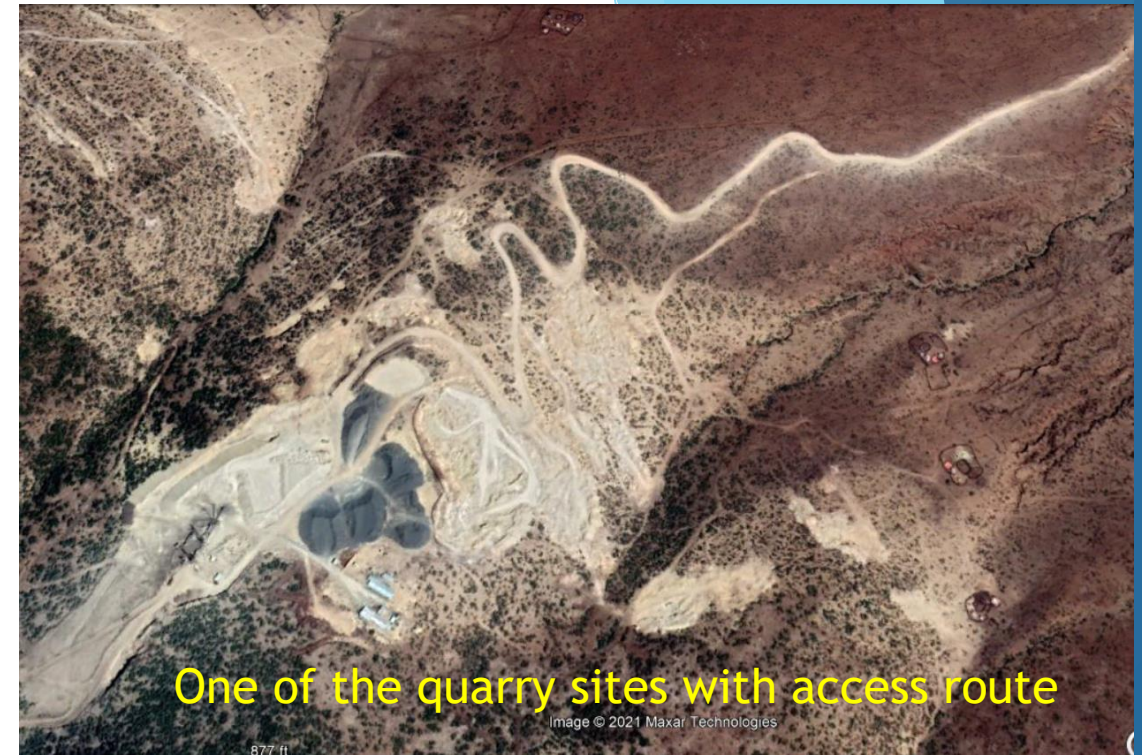
One of the quarry sites with access route

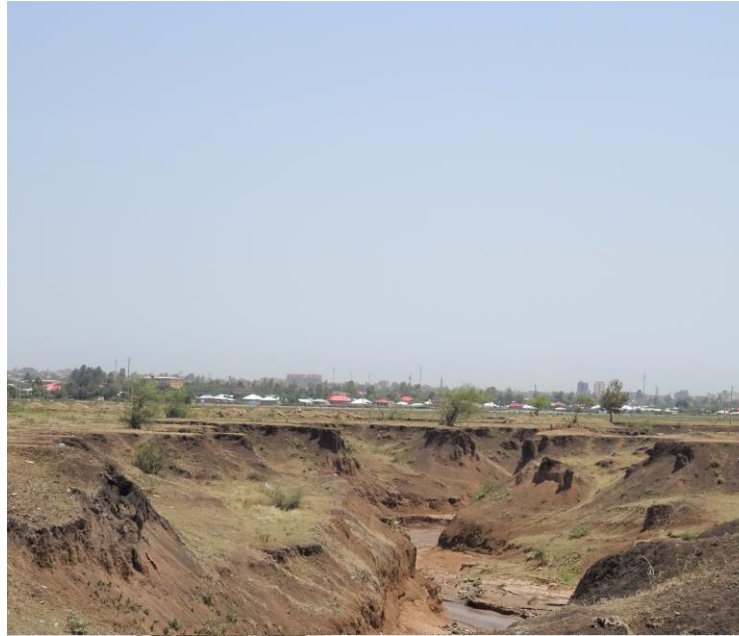
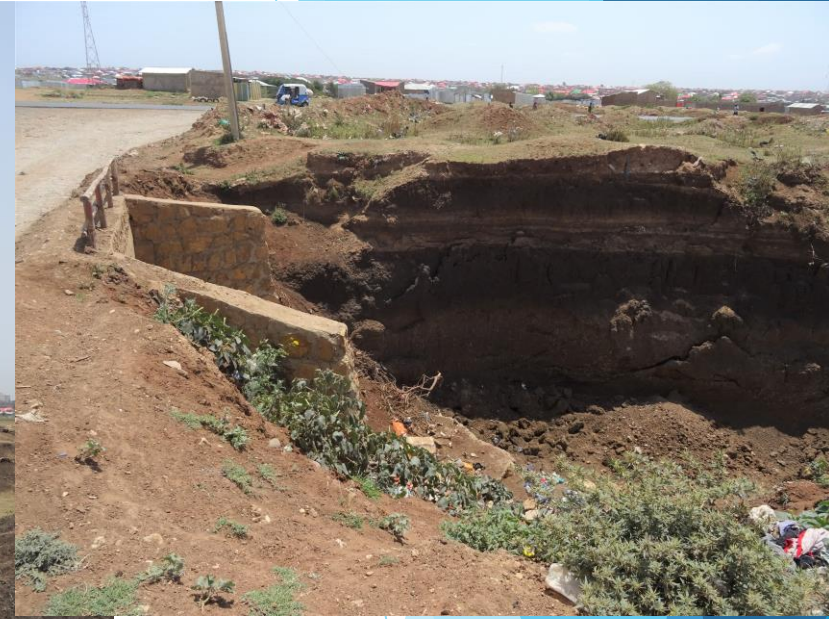
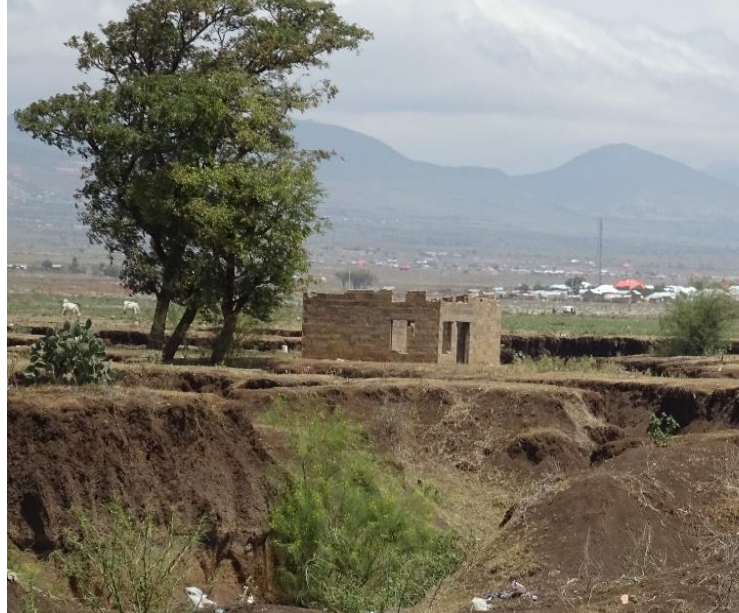
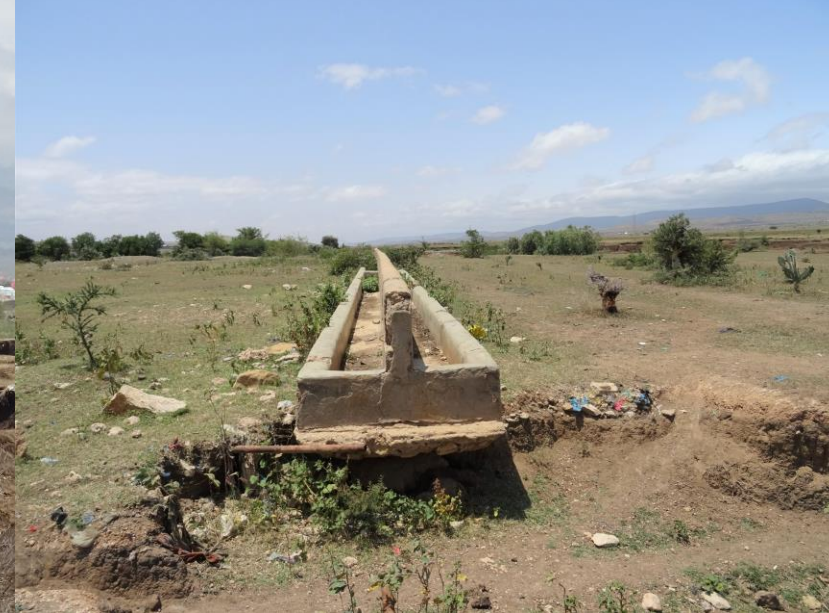
- ❖ Damaging infrastructures (water, road)
- ❖ Damaging productive arable and pasture lands
- ❖ Moving to the city at rate of about 70m per year
- ❖ Draining shallow ground water
- ❖ Hamper access to field, farm operation and transport

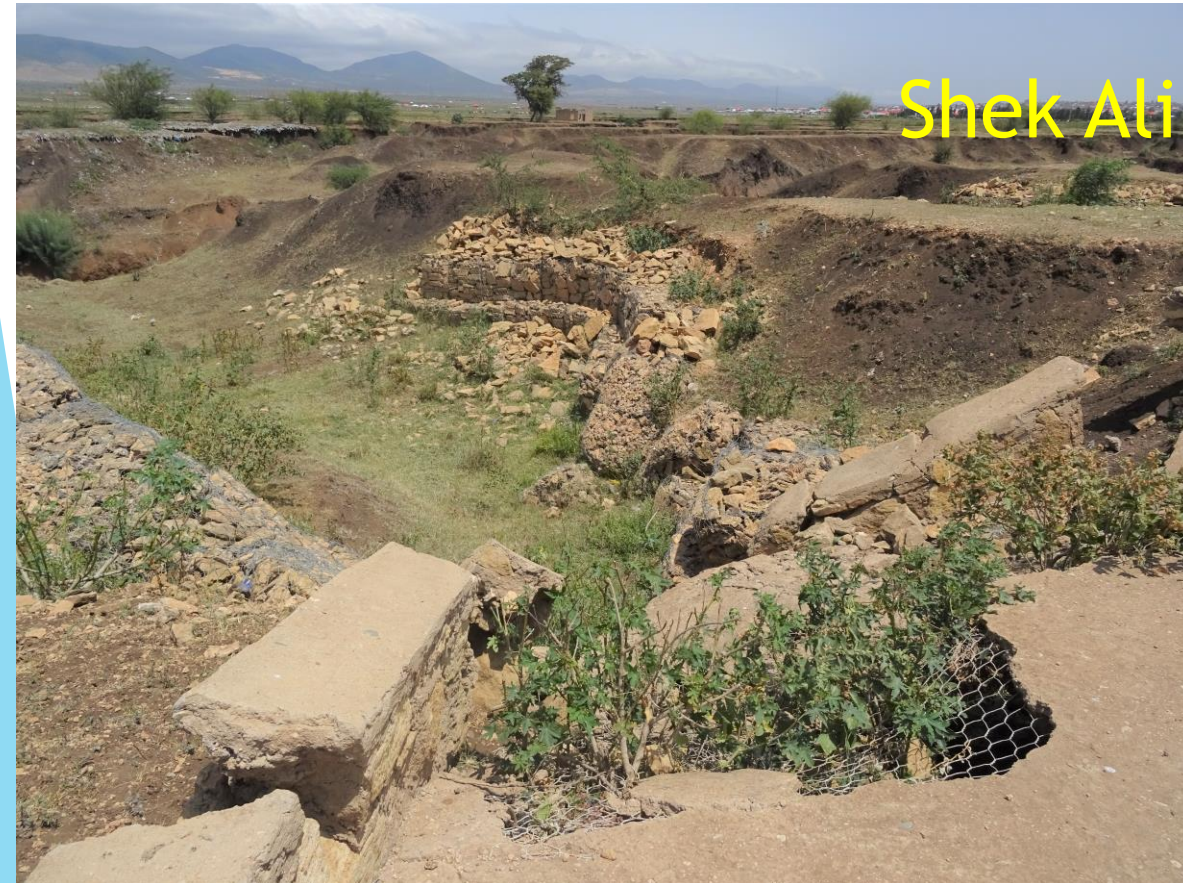
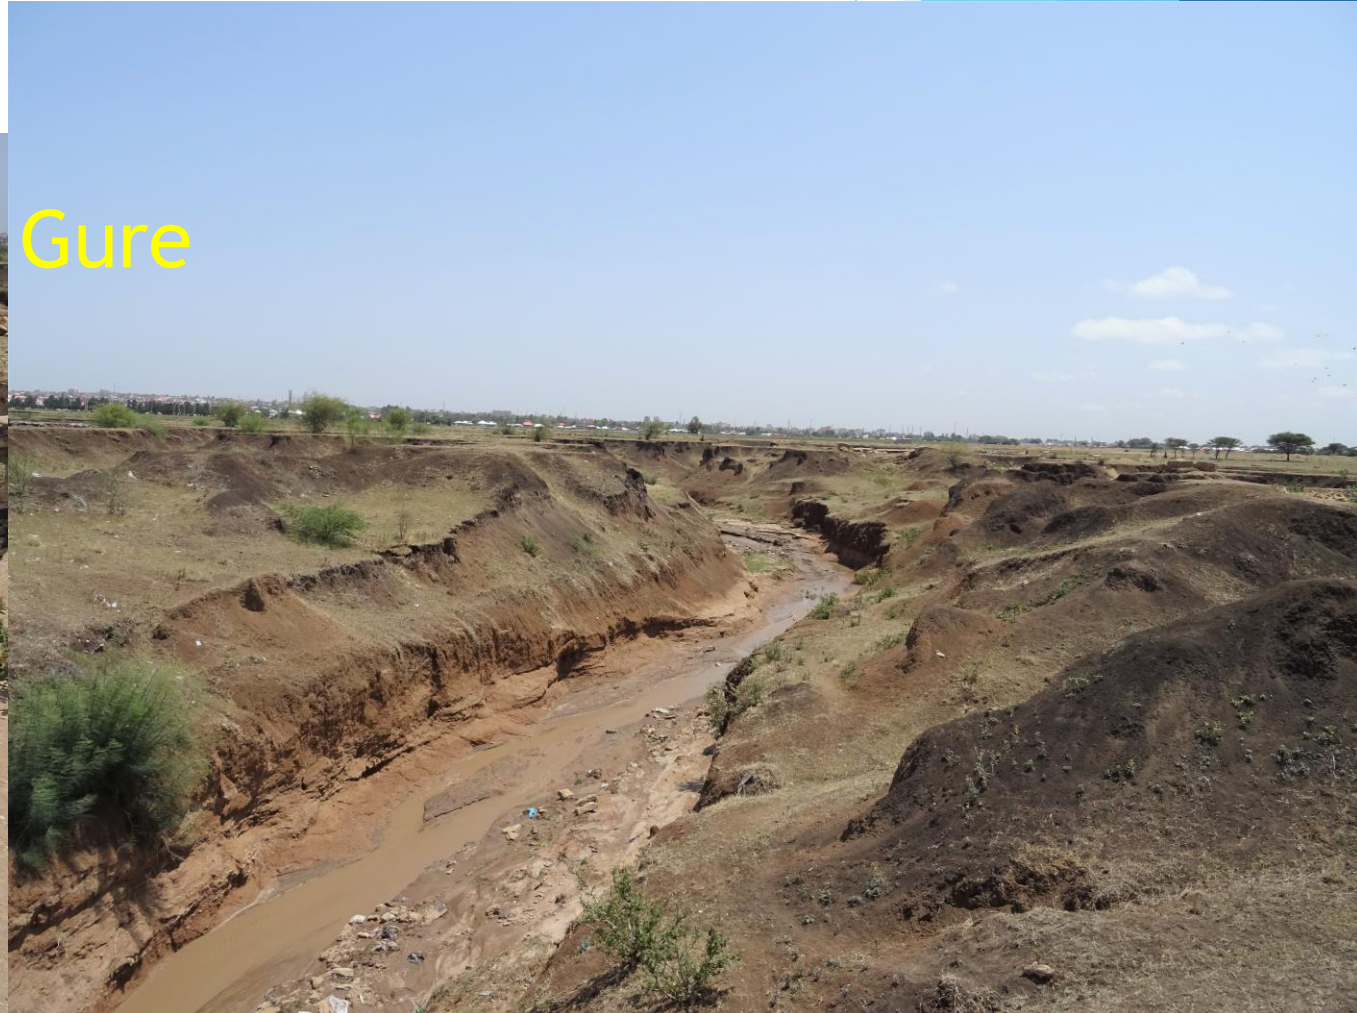
- ❖ There were effort made to rehabilitate the gully at Shek Ali Gure site (southern part of the city)
- ❖ With stone masonry and gabion check dams
- ❖ This effort is not successful as the intervention was made at the **mid-way of the watershed**, where the concentrated flood comes from the upper catchment
- ❖ The structural measures were not supported by the biological (vegetative) measures

The structures are damaged and the gully is advancing to the city

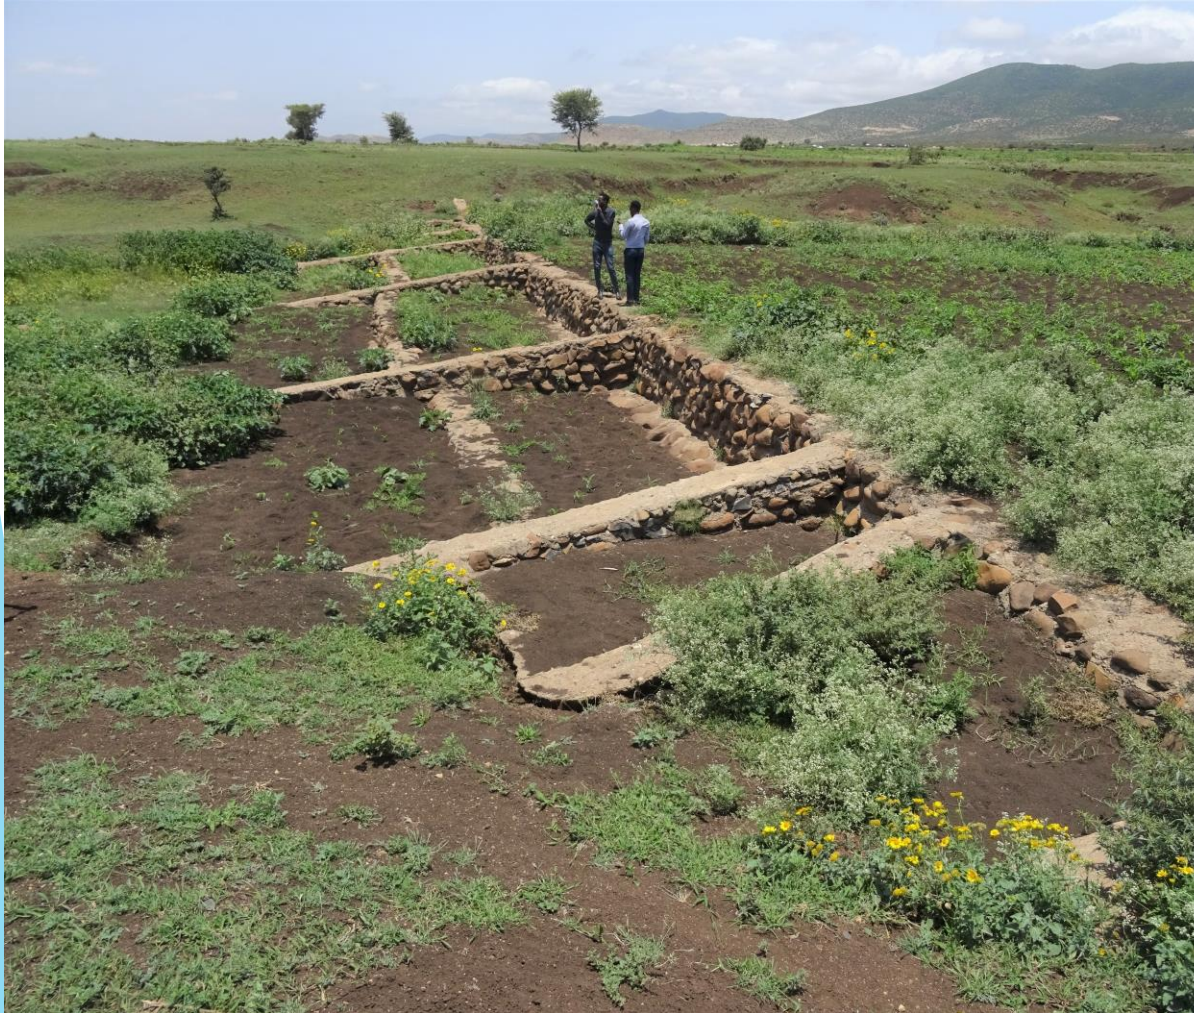
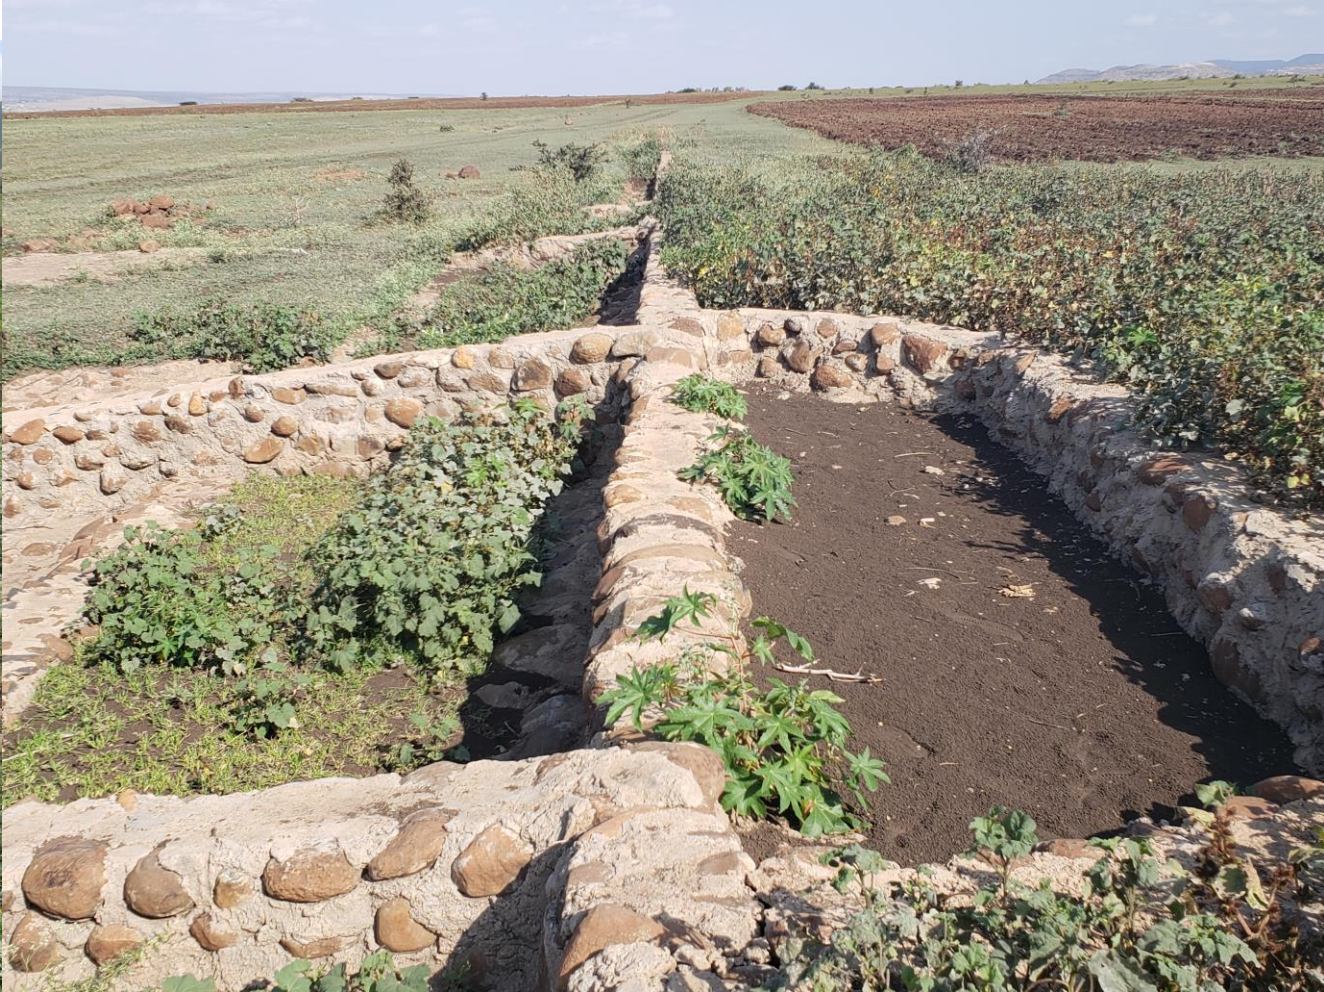
WSW- status in pictures (Bolidid and Karamara)

- ❖ Many masonry water spreading weirs were constructed at: Karamara, Bolidid Cascades and Jigjiga¹⁰ (water spreading weir already damaged)
- ❖ Masonry check dam constructed at Karamara cascade
- ❖ These structures at Bolidid and Karamara cascades are contributing to soil and water conservation
 - ❖ Visible moisture difference at the u/s and d/s of the WSWs
 - ❖ Significant volume of sediments (trapped at the structures and healing the gullies)
 - ❖ Helped farmers to grow crops (mainly sorghum and maize)
- ❖ Local capacity building (construction by trained local masons)
- ❖ Contributed to job creation

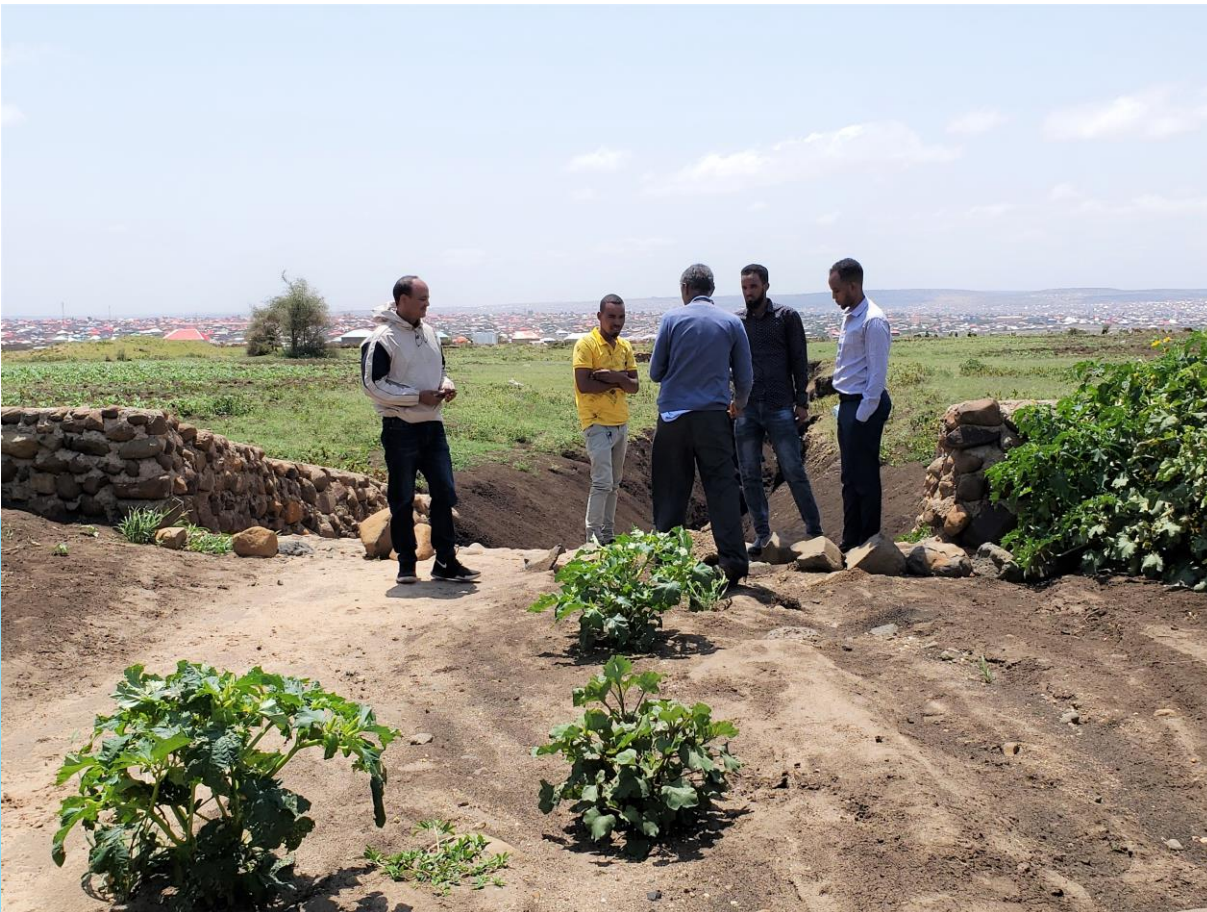
GiZ-SDR interventions...

Attention!

- ❖ Adding height of the WSWs & check dam at the Karamara cascade
- ❖ Maintenance works of one WSW apron at the Karamara cascade

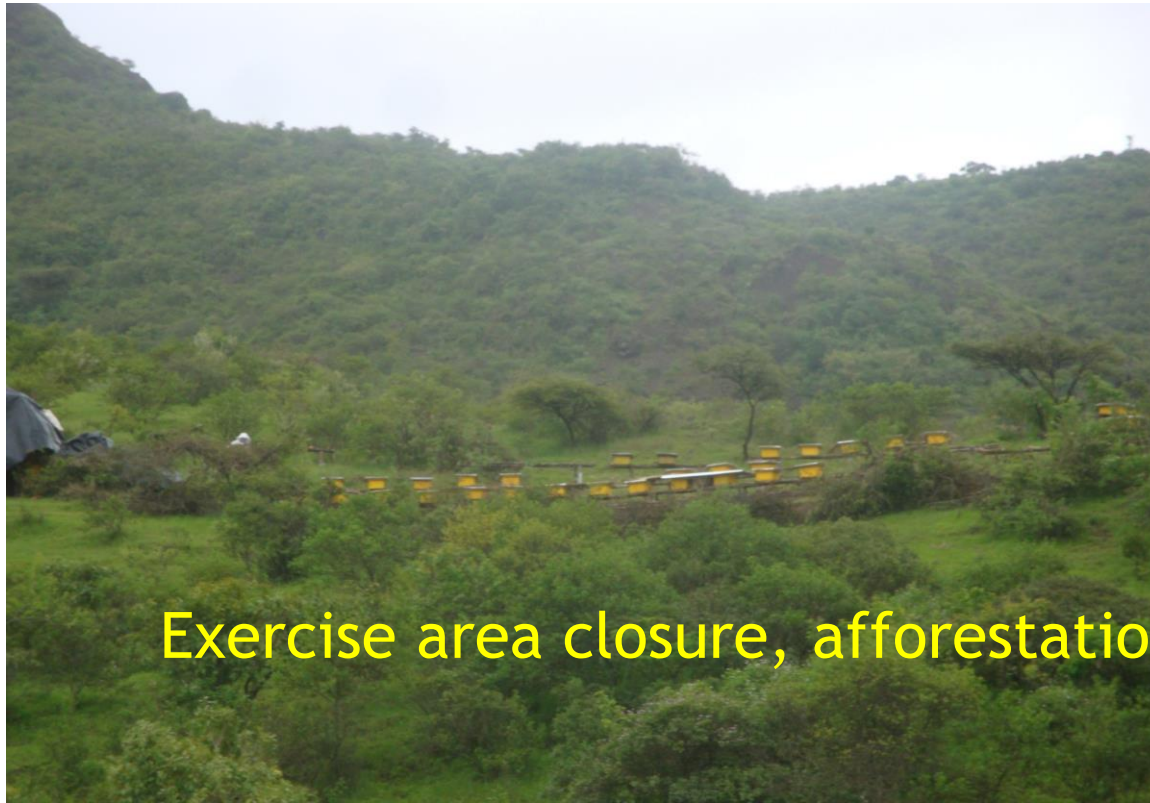
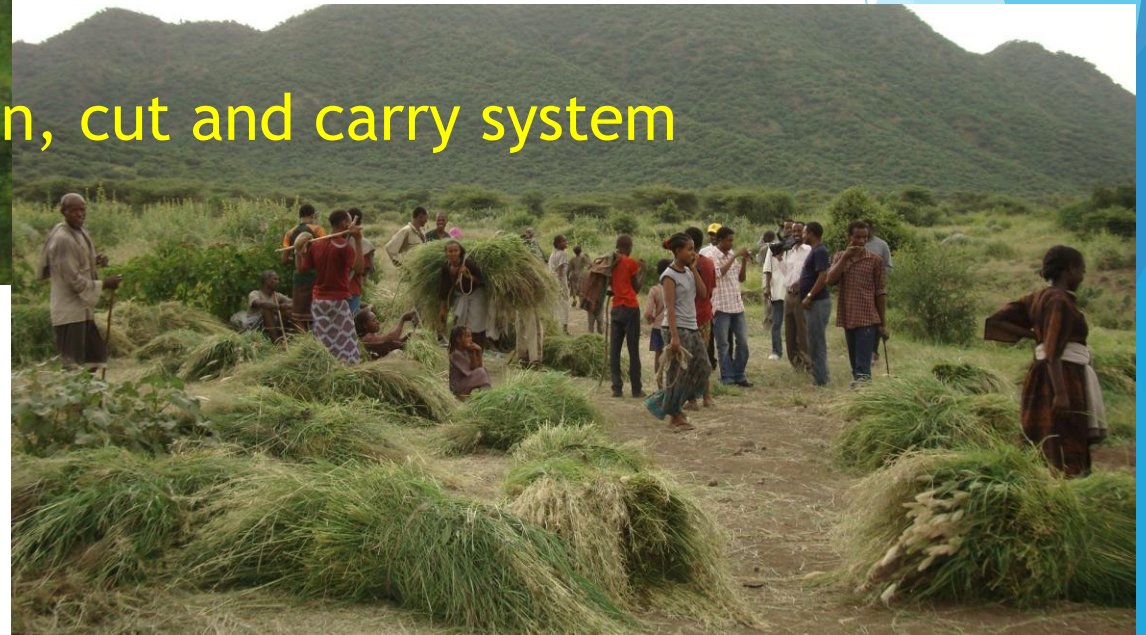
Exercise area closure, afforestation, cut and carry system

❖ Needs linking to livelihood alternatives and circular economy in terms of:

- Beekeeping, beeswax processing
- Fodder production
- Nursery development
- Livestock fattening
- Alternative energy (biogas, solar)

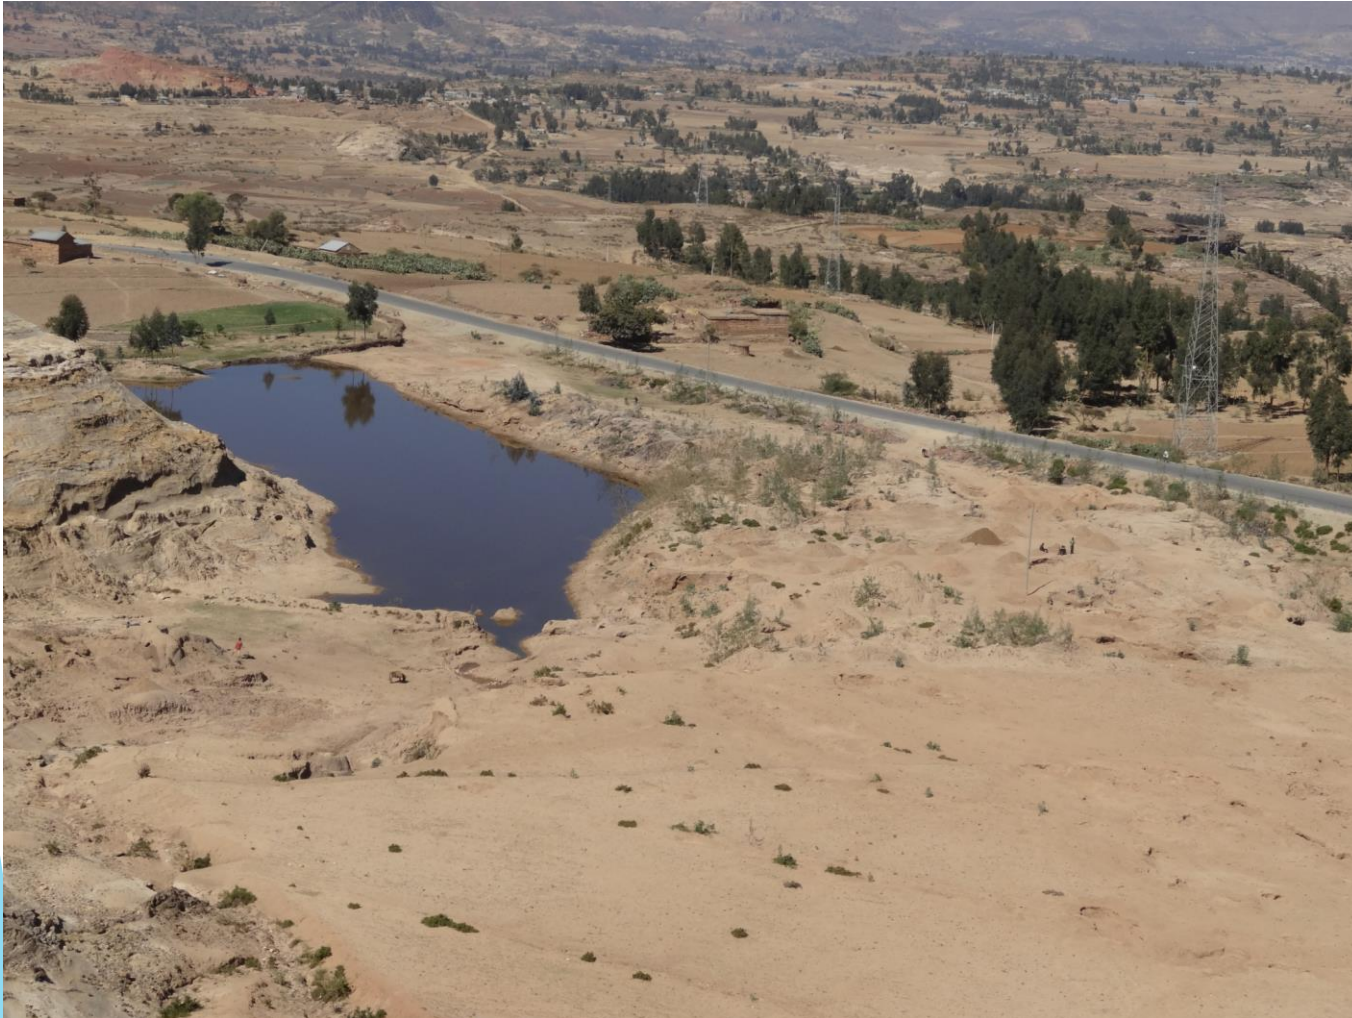
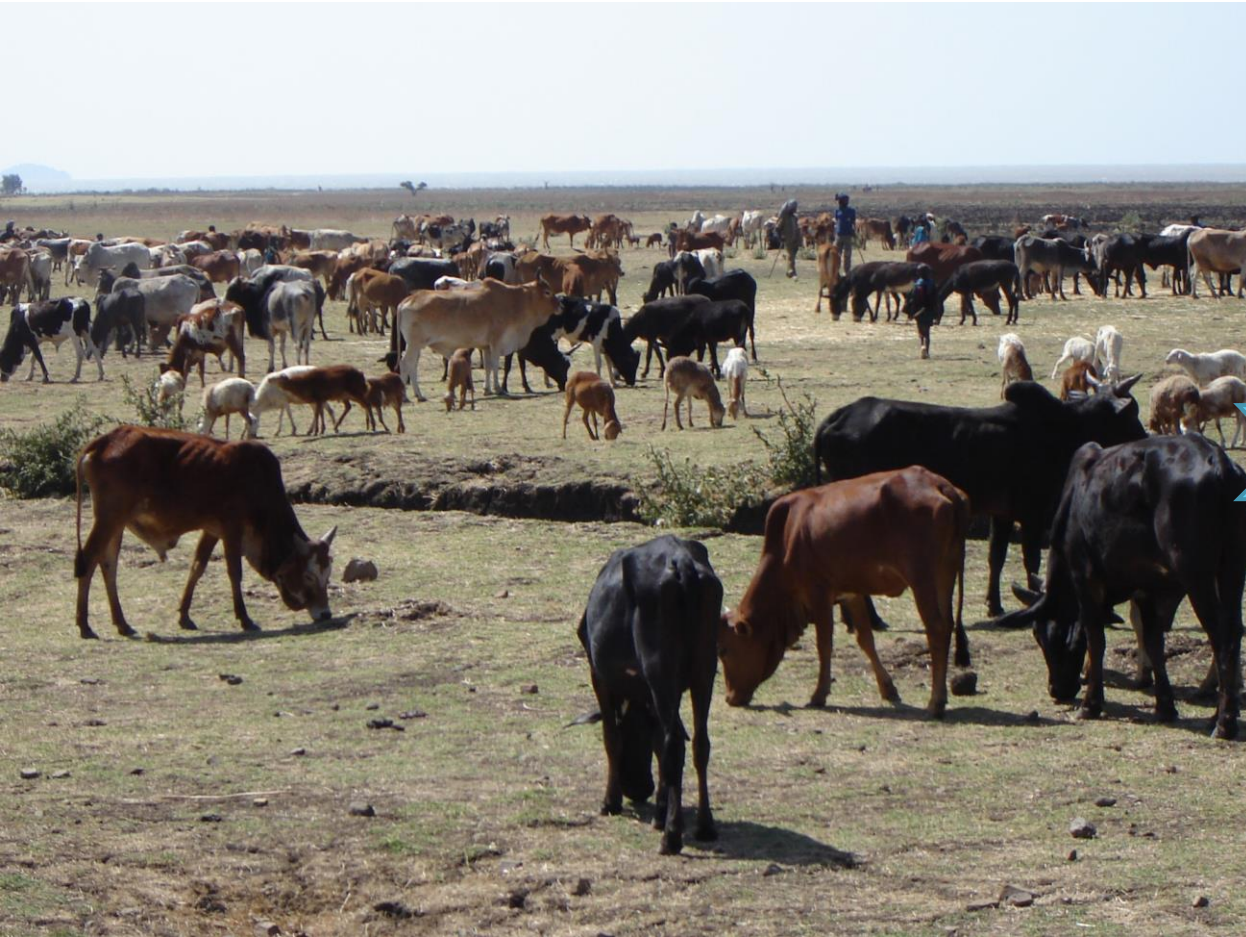
- ❖ **Road Water Management for multiple advantages**
 - ❖ For Road Safety
 - ❖ Water harvesting for agriculture
 - ❖ Water Supply for human and livestock
 - ❖ Minimize soil erosion/gully
 - ❖ Helps groundwater recharge
